## **Case Study: Natural Resources Conservation Service, Emergency Watershed Protection**

Project: Butte Creek Emergency Watershed Protection Phase II "Parrott-Phelan Irrigation Diversion"

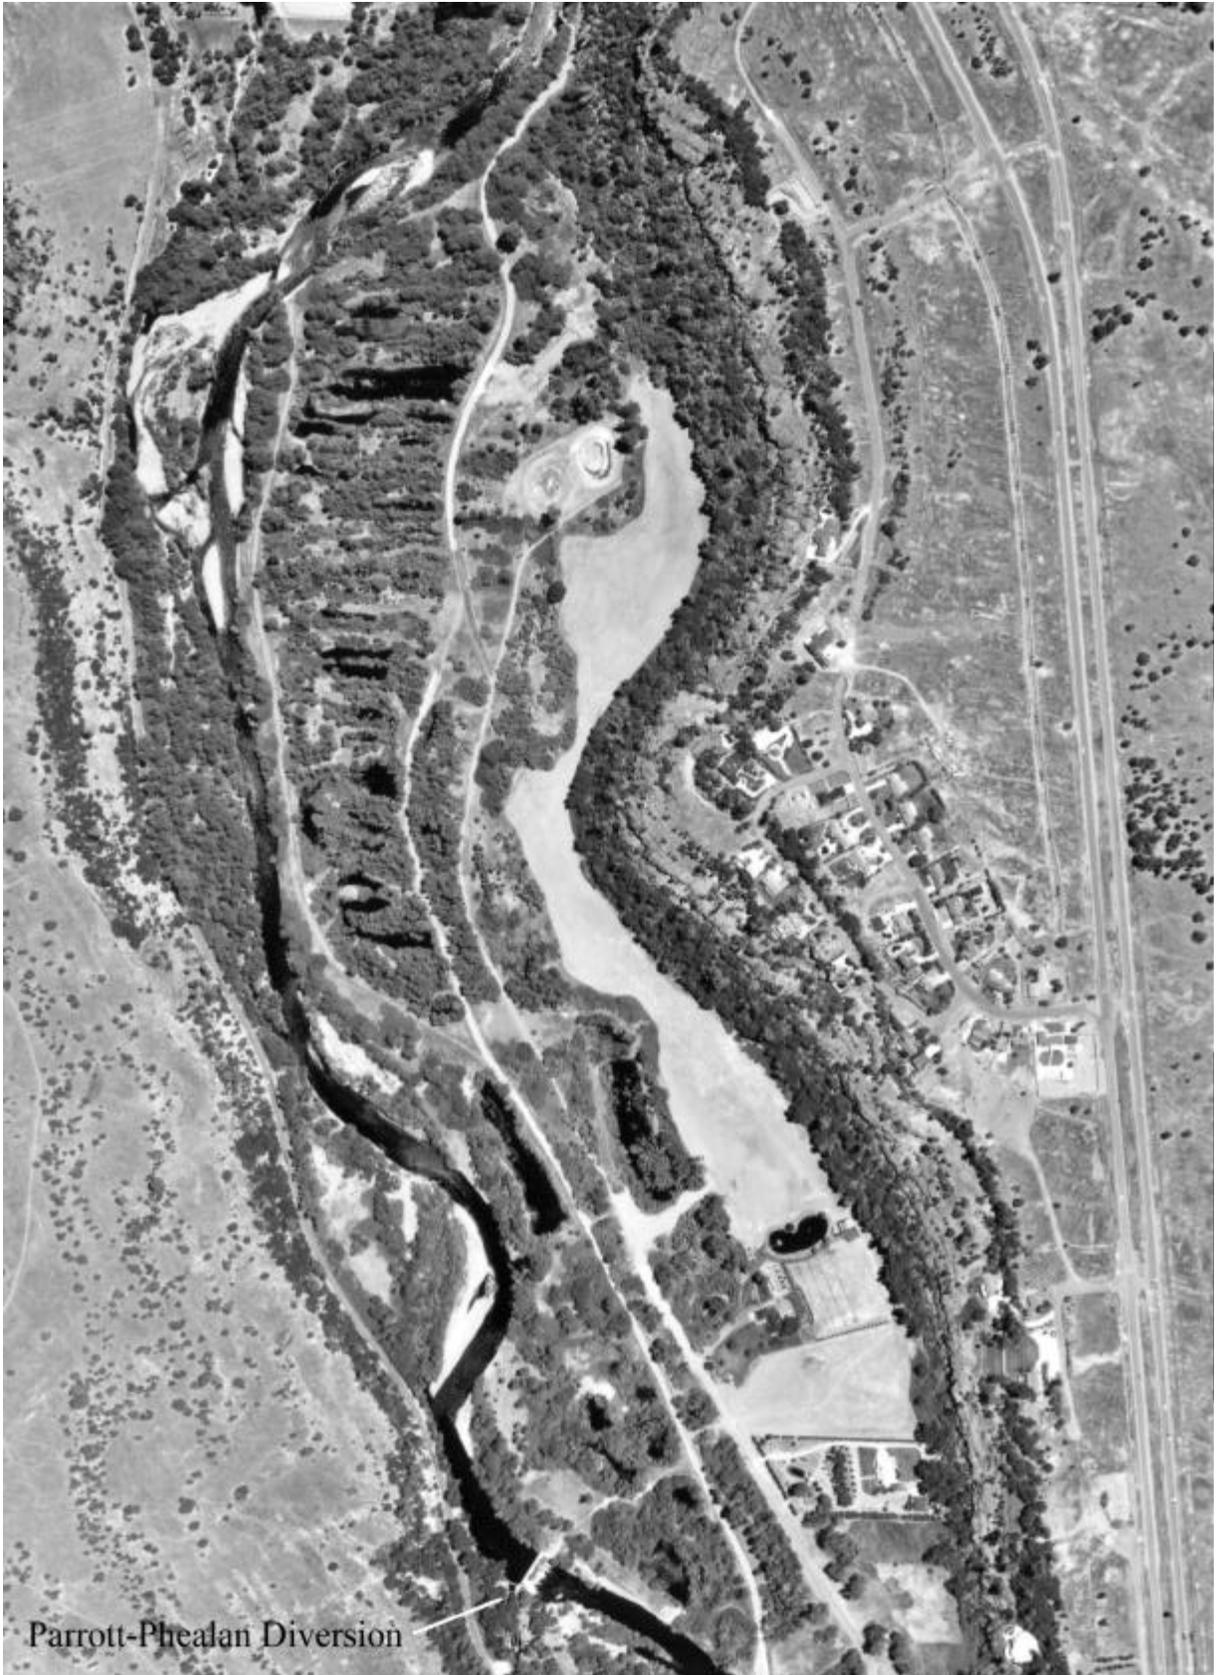
Figure 3.2 Parrott-Phealan Diversion Area Aerial Photograph 1995

This is exactly what happened at the Parrott-Phelan Diversion Dam, also known as the Okie Dam. During the night of January 31, 1996, Butte Creek changed its course from where it ran through the dam/diversion structure, and shifted to the south, leaving the dam and diversion approximately 500 feet from the new channel (see Figures 3.2 and 3.3).

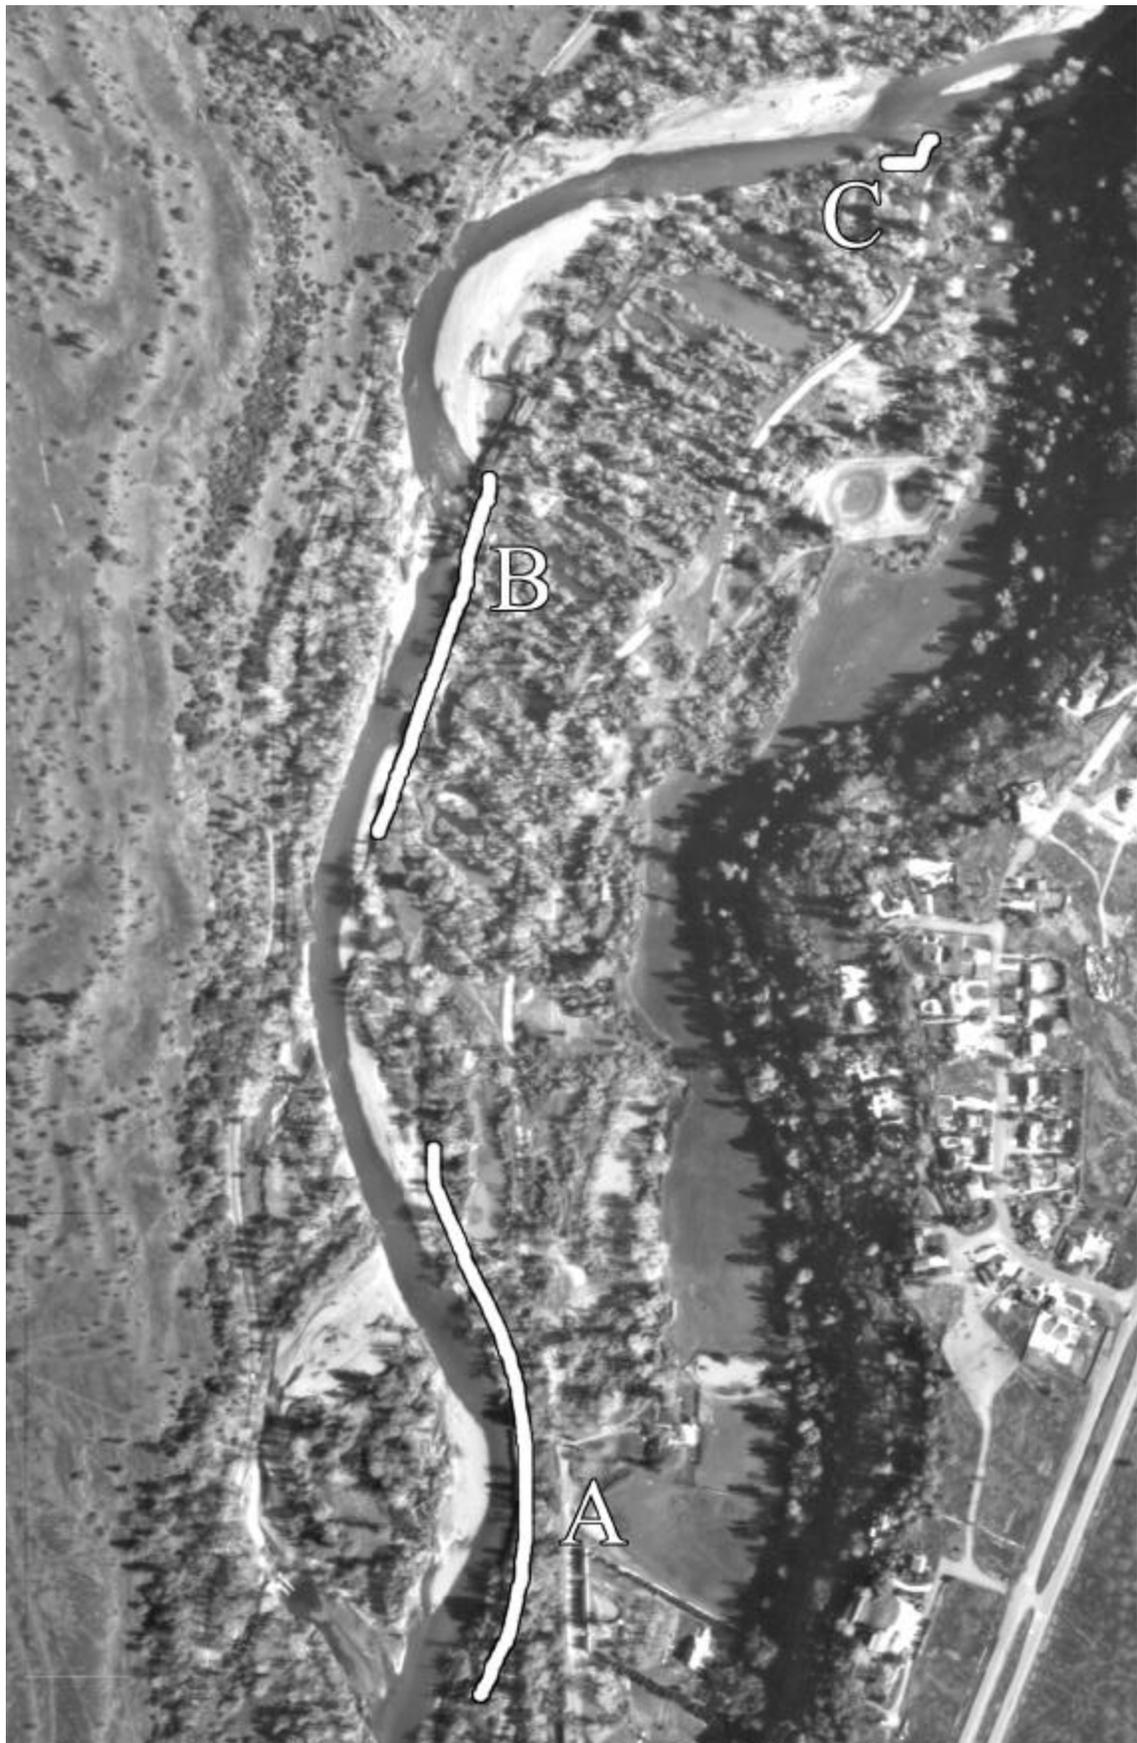
Figure 3.3 Parrott-Phealan Diversion Area Post-1997 Flood  
White lines represent NRCS EWP project areas.
